FAILURE OF TETON DAM

A REPORT OF FINDINGS

by
U.S. DEPARTMENT OF THE INTERIOR
TETON DAM FAILURE REVIEW GROUP
April 1977

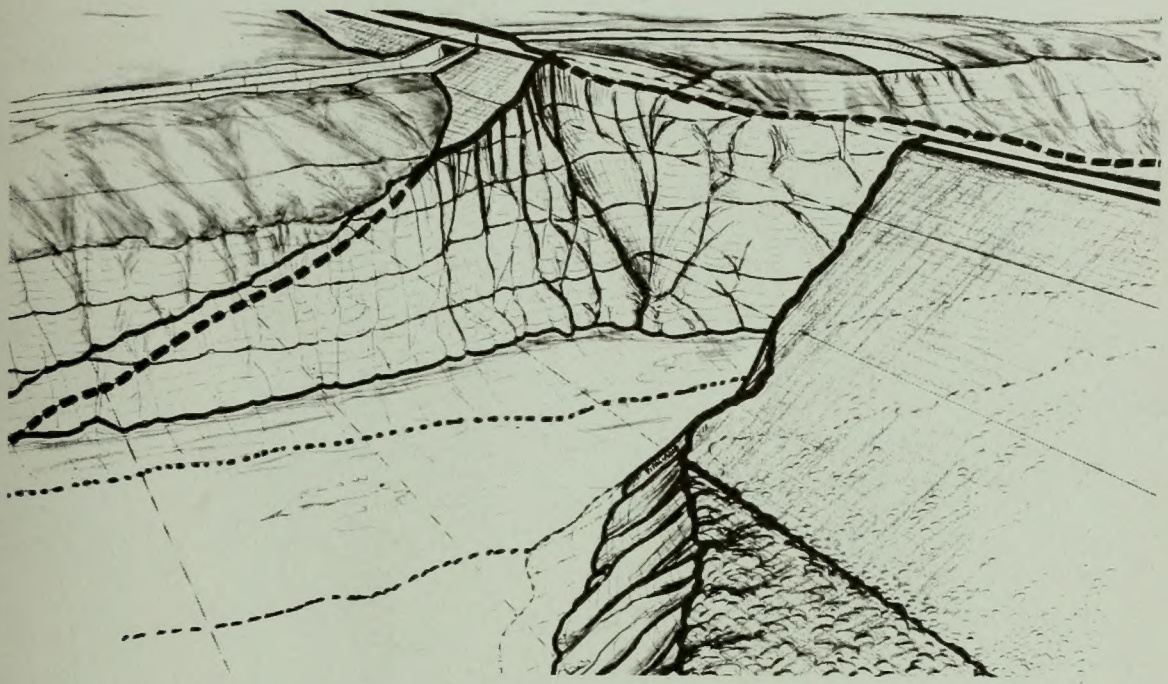
Frontispiece.—Aerial view of Teton damsite after the failure of the dam.

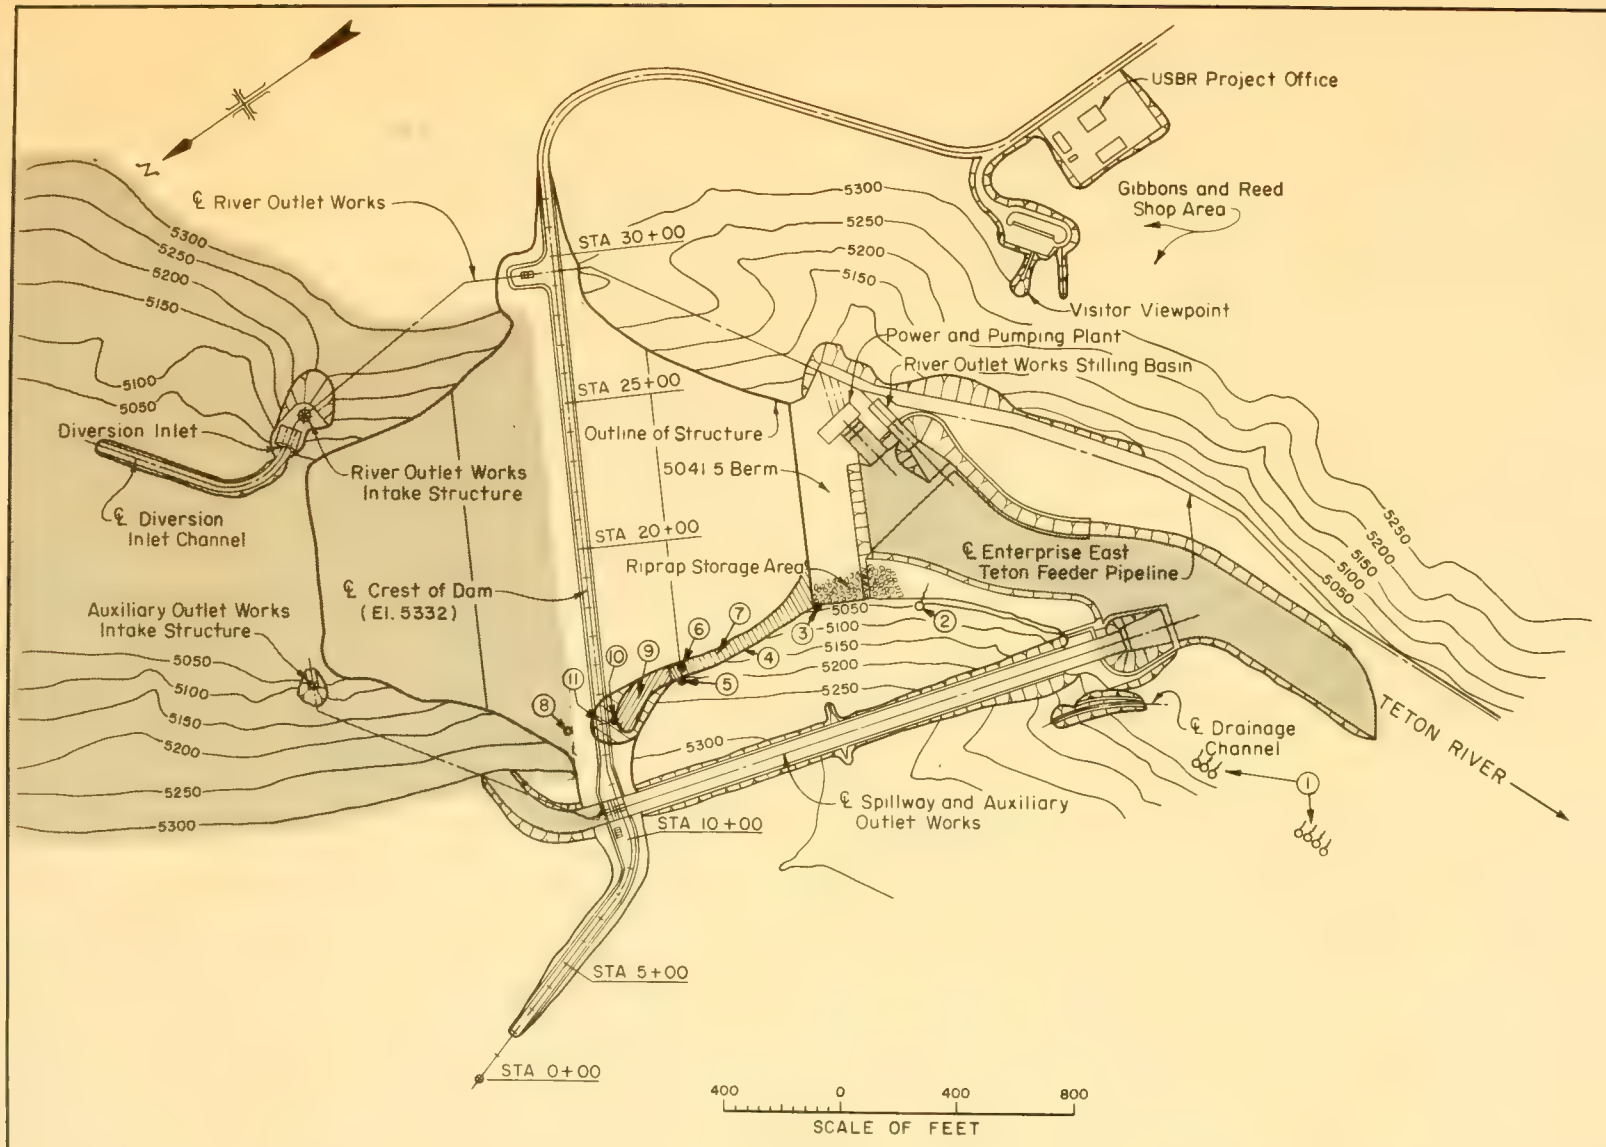
Between 10:00 a.m. and 10:30 a.m., a wet spot developed on the downstream face of the dam at El. 5200, and about 15 to 20 feet out from the right abutment. The wet spot quickly began to leak at a rate of 10 to 15 cfs, and eroded zone 5 material from the face of the embankment. At about 10:30 a.m., Robison, Aberle, and others noted a loud sound followed by the sound of rapidly running water. Robison comments in a supplemental statement:

> "This leak developed almost instantaneous at about 10:30 a.m. and let loose with a loud roar."

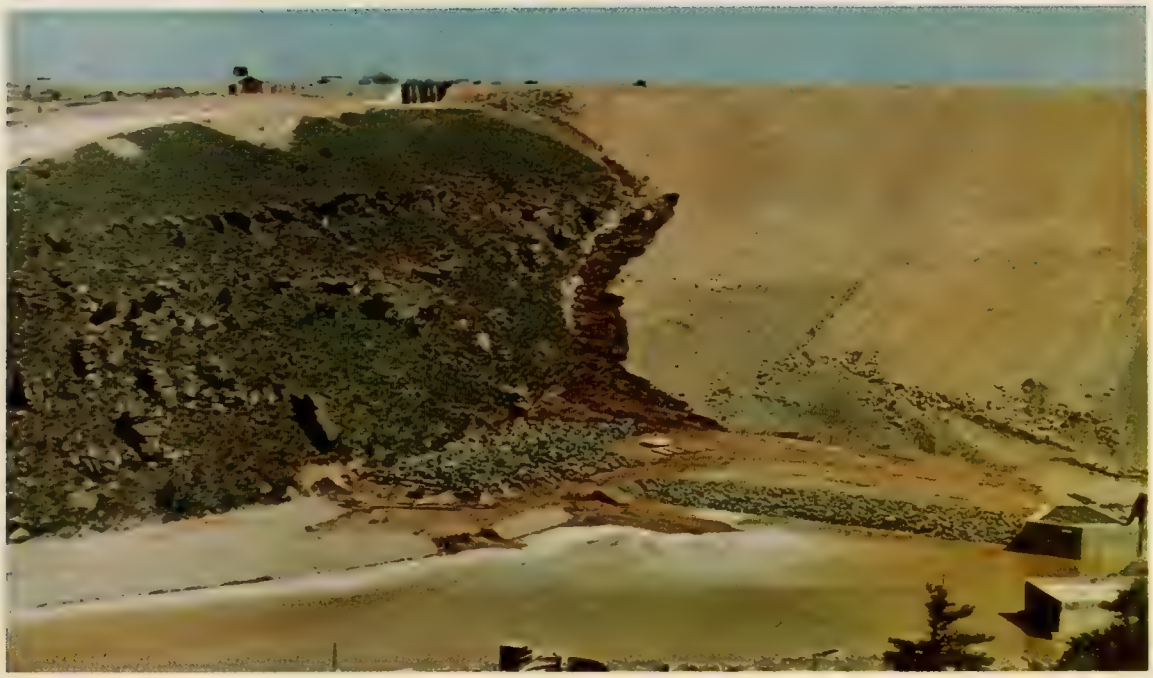
Figure 22.—Flow increasing from leak at El. 5200.

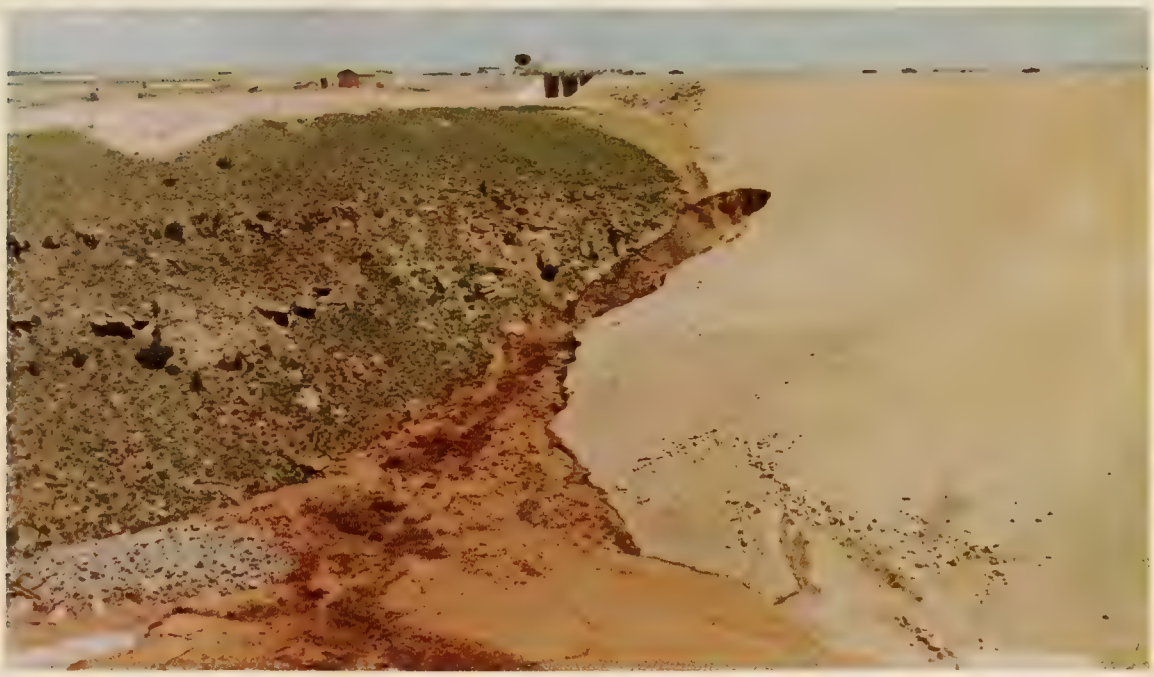
Figure 23.—Dozers lost in leak at El. 5200.

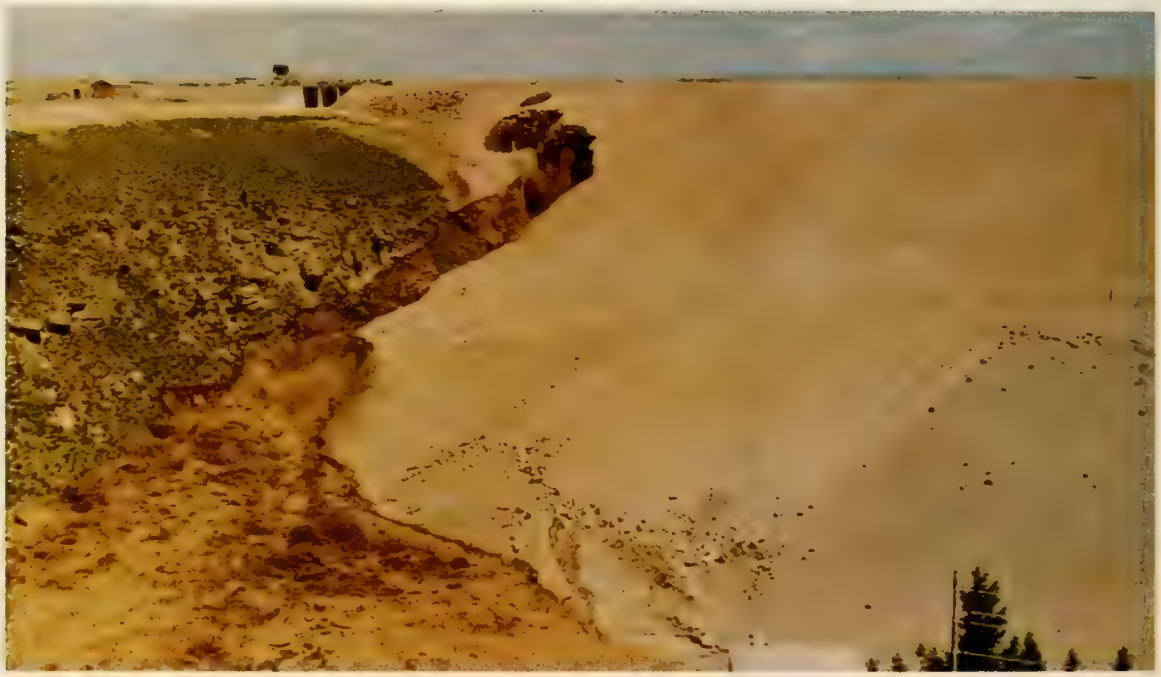
Figure 25.—Second hole in downstream slope of dam just after 11:30 a.m., June 5, 1976.

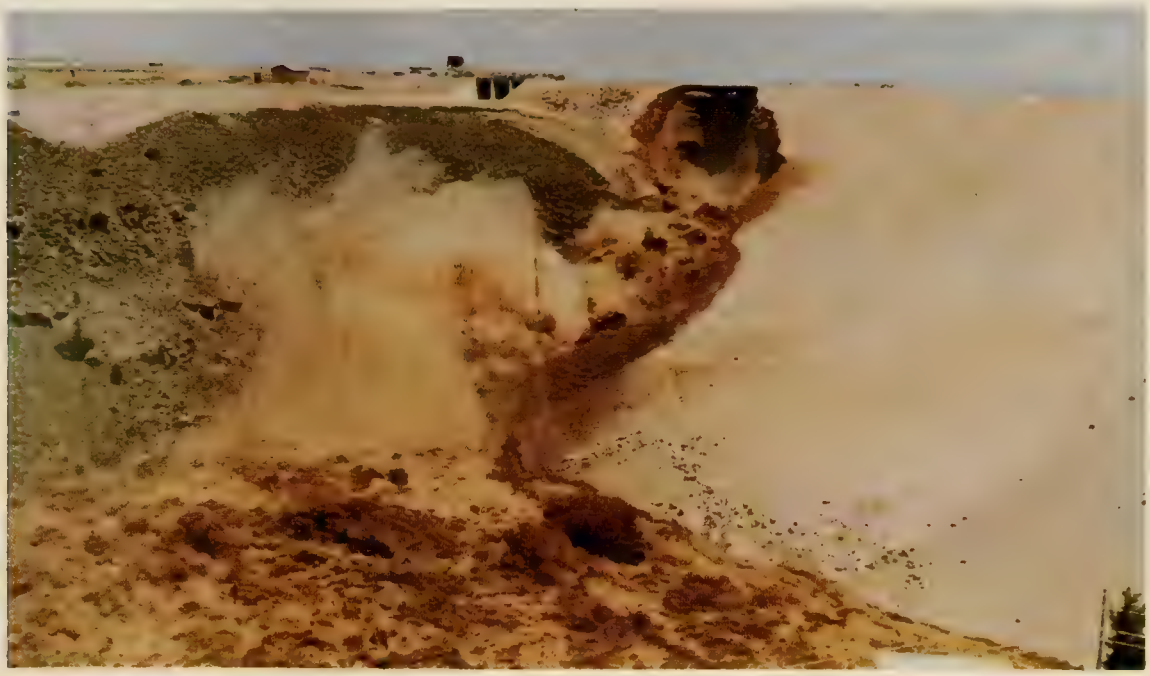
Figure 27.—Dam crest breaching 11:55 a.m., June 5, 1976.

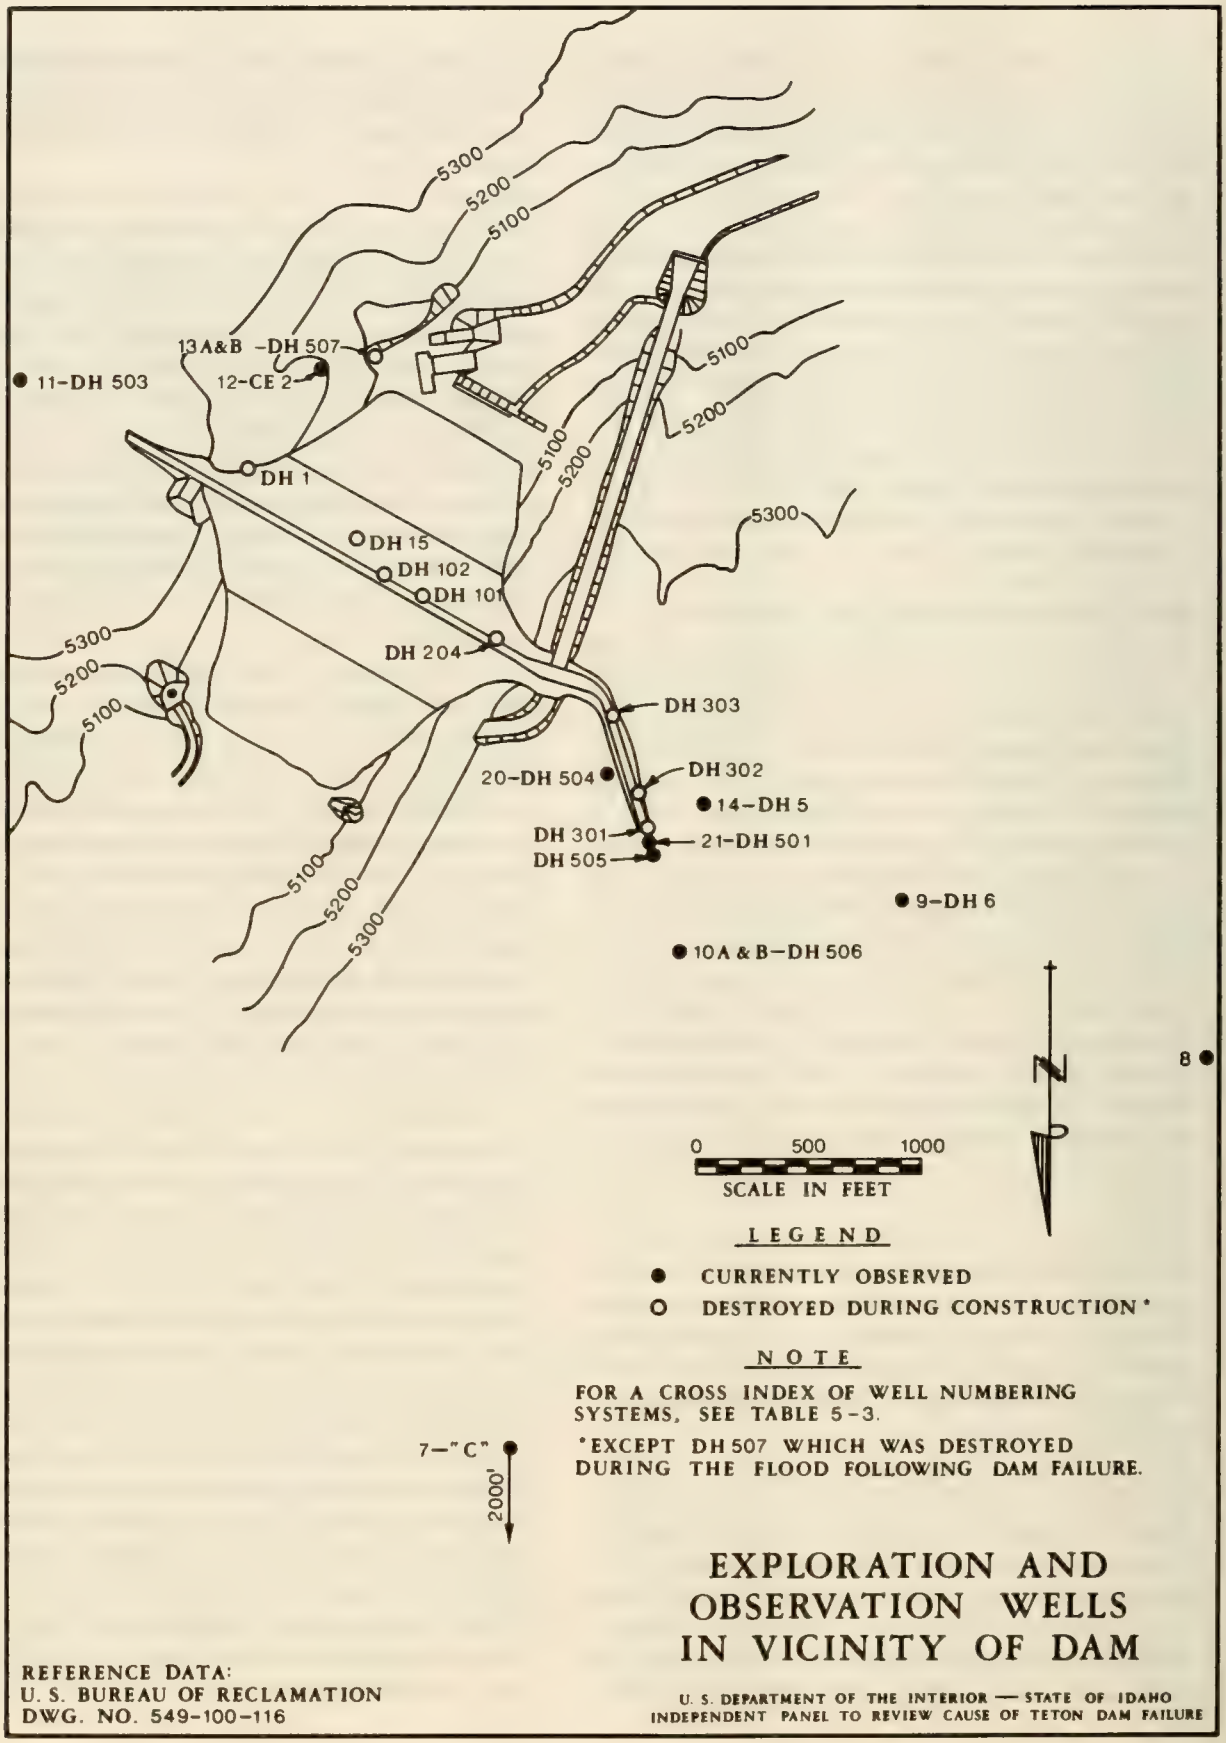
An attempt was made to analyze behavior of the groundwater in the area of the right abutment during the filling of the reservoir. This analysis was made difficult by the low number of groundwater observation wells, the absence of wells in locations critical to the analysis, and the lack of frequent readings. However, the analyses that were performed tend to confirm the permeability of the welded tuff. The rates at which the water levels in the observation wells followed the rise of reservoir water varied over the filling period. This may be interpreted to mean that zones of relatively higher permeability were being encountered by the rising water. Figure 30 shows the relative positions of the water levels in the observation wells and in the reservoir with time.

Figure 29.—Location of exploration and observation wells in the vicinity of Teton Dam.

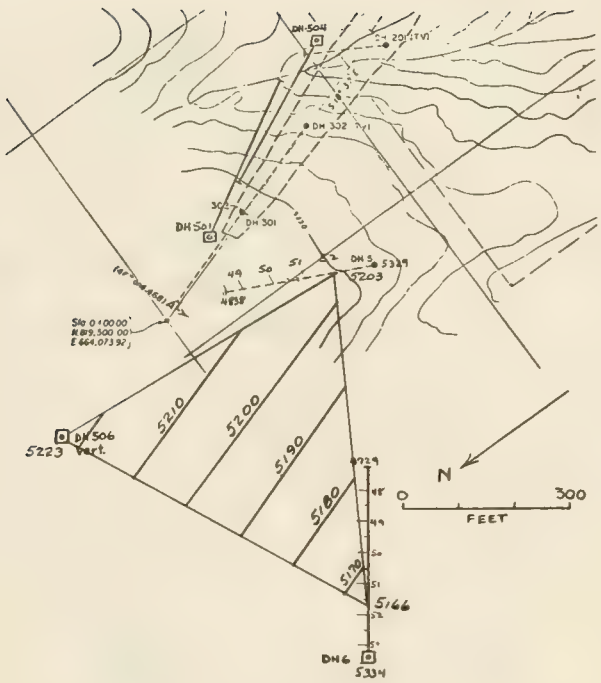
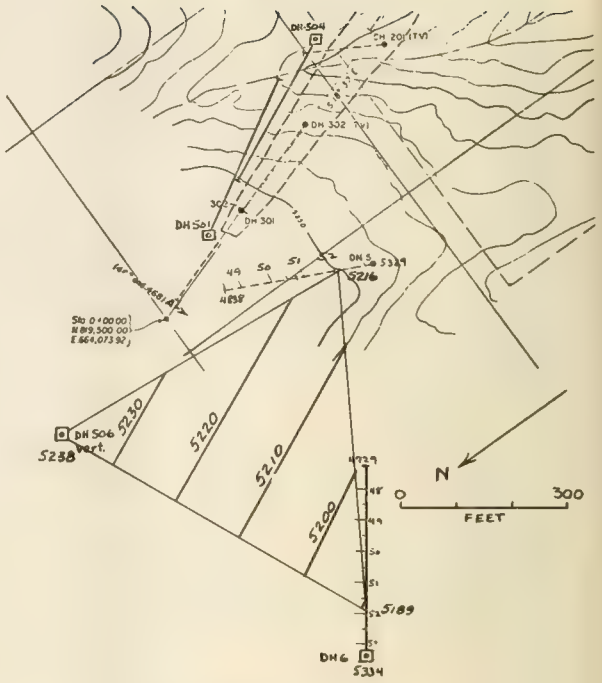
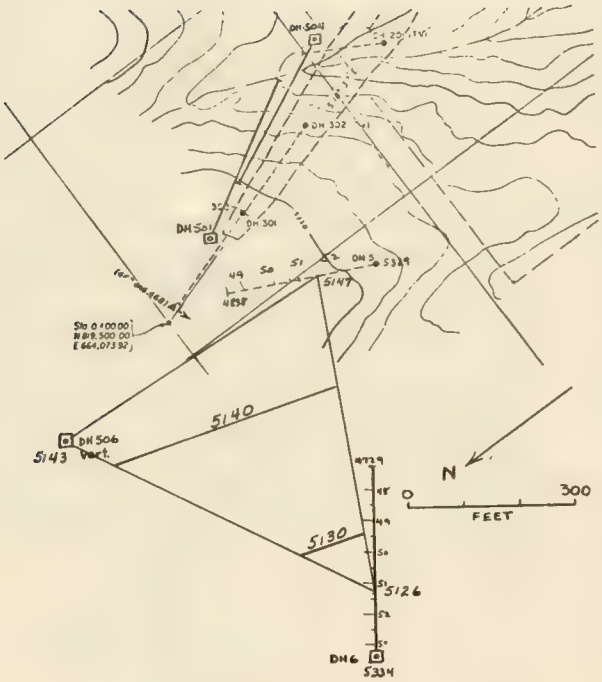
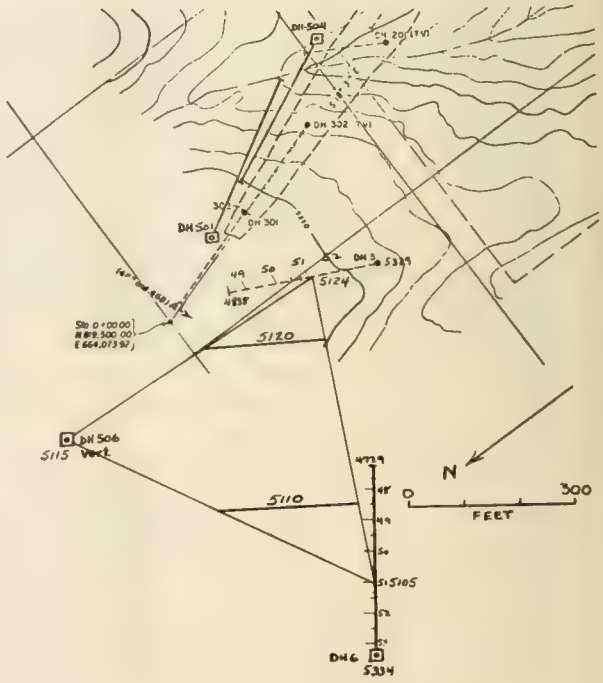
Contours of the groundwater surface at various times were drawn from water levels in three observation wells, drill holes 5, 6, and 506. A sequence of selected contour maps, covering the period of time from reservoir filling to just after failure is presented on Figure 31. These contours indicate apparently normal behavior of reservoir water flowing through permeable abutment rocks along and around a less permeable curtain of grouted rock.

Figure 31.—Contours on groundwater surface adjacent to Teton Dam. (Sheet 1 of 2)

Figure 31.—Contours on groundwater surface adjacent to Teton Dam. (Sheet 2 of 2)

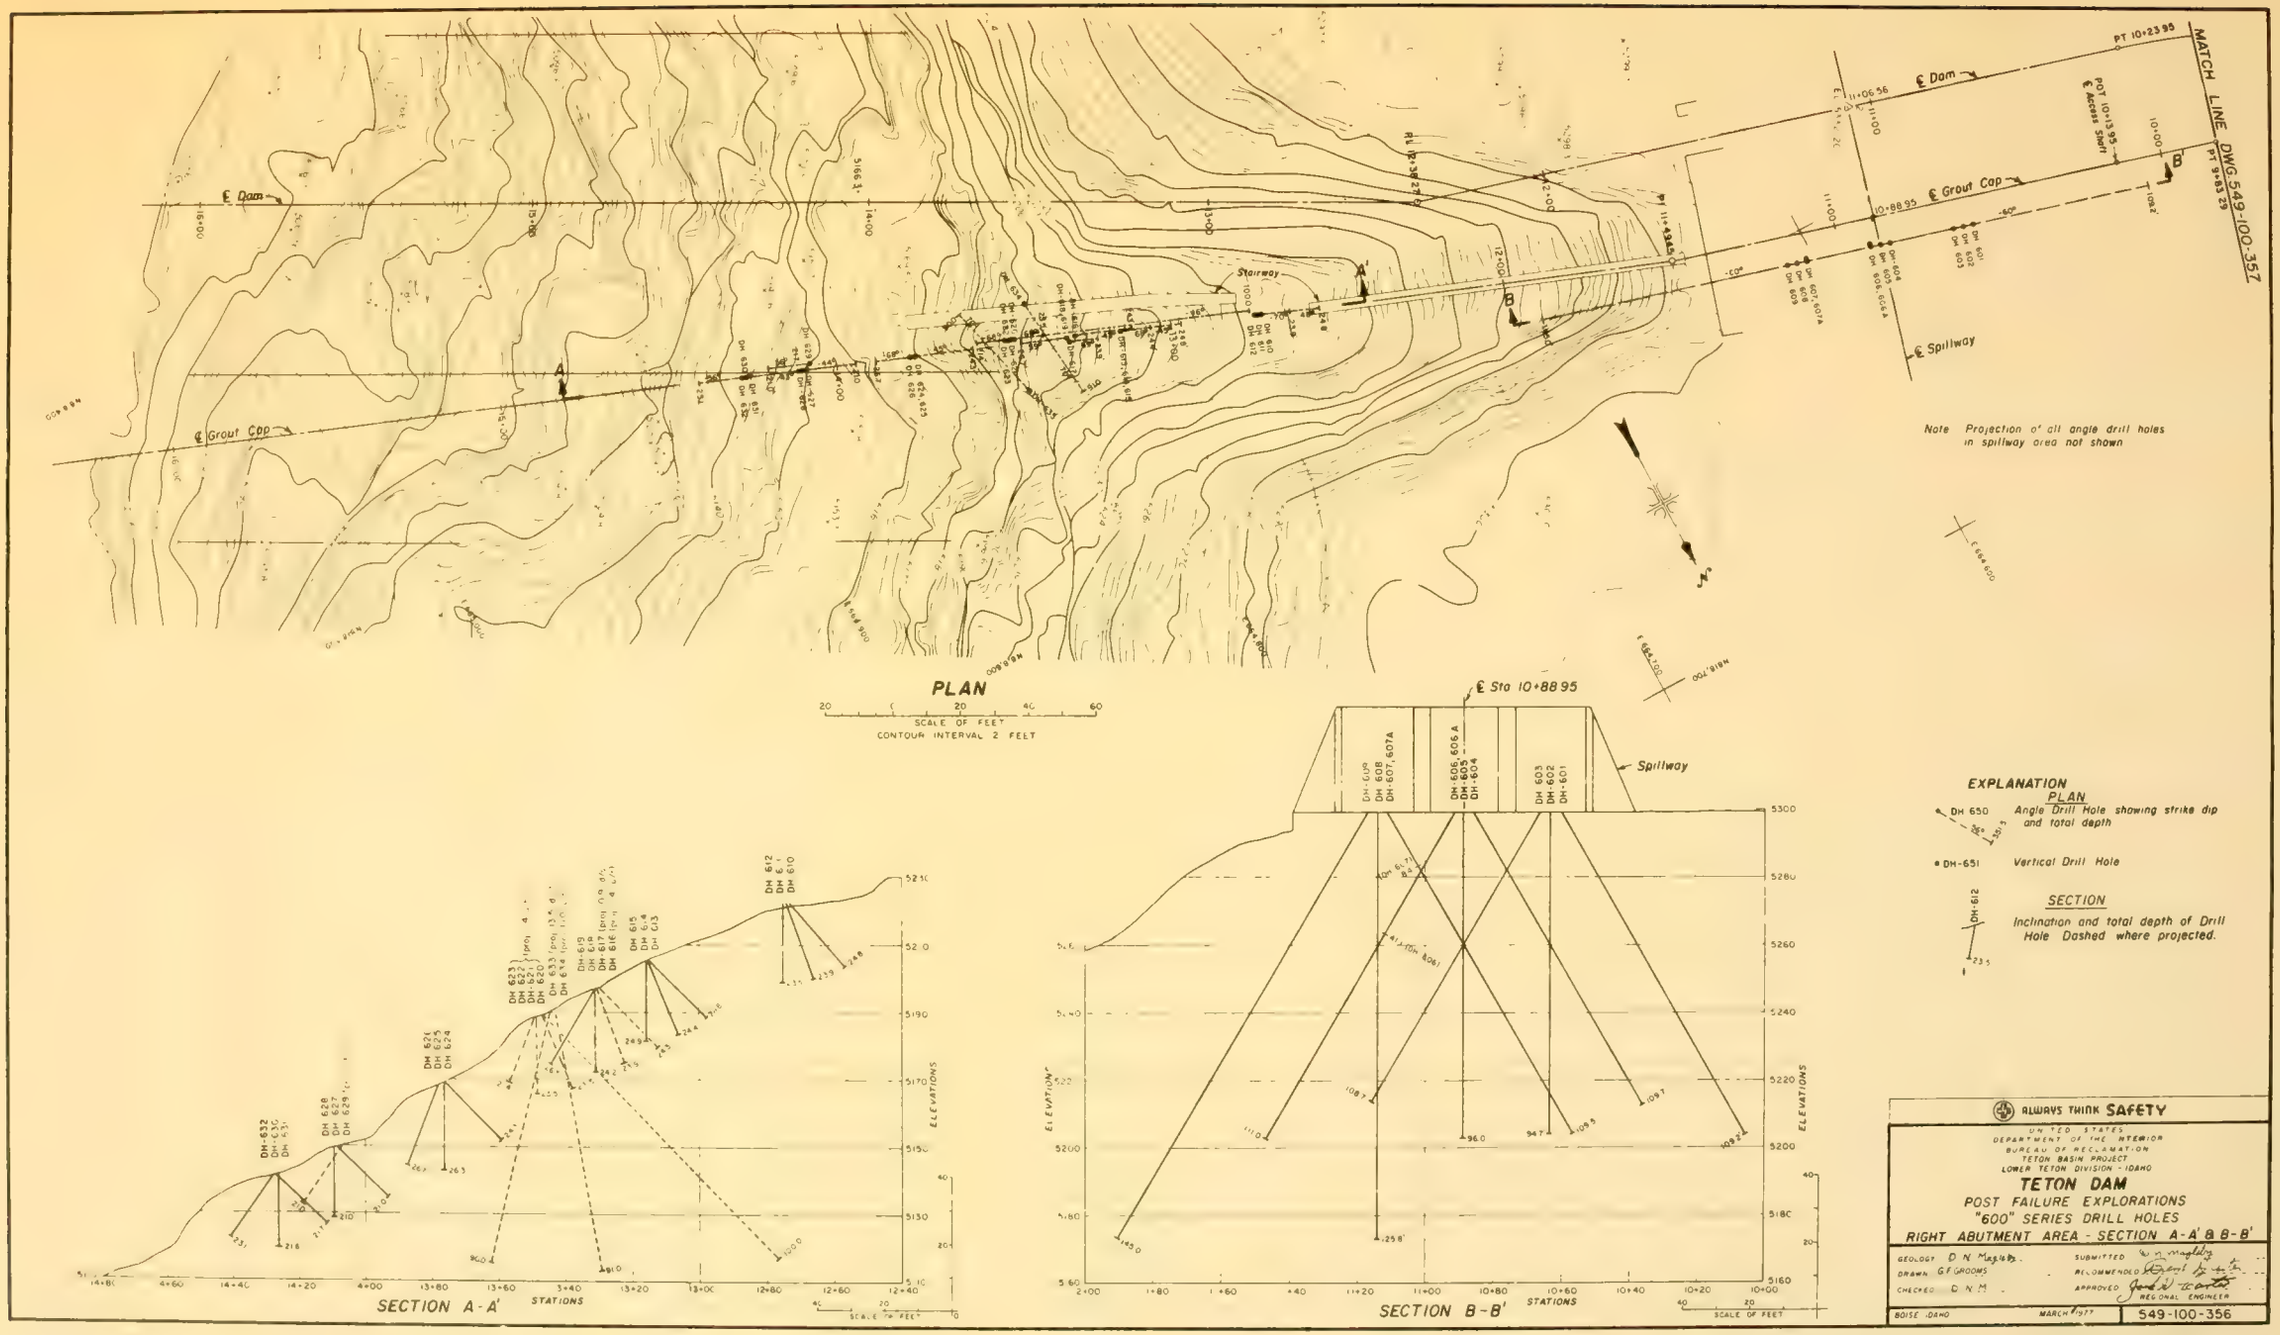
Although the main purpose of the postfailure core drilling program was to check the adequacy of the grout curtain, much valuable information was obtained on the condition of the abutment rock. The locations of these borings are shown on Figure 32. The boring logs and water pressure data are contained in Appendix C. The postfailure drilling indicated zones of high permeability in the vicinity of Sta. 13+50, even though curtain grouting had been performed. However, it is not known if this permeable zone occurred as a result of loosening of jointed rock during the failure. One of the postfailure borings in the vicinity of Stas. 3+00 to 5+00 (drill hole 650) was oriented so that it penetrated rock outside from the grout curtain. Water pressure tests in this boring confirmed the high permeabilities observed during the preconstruction investigations.

Figure 32.—Locations of postfailure core borings (sheet 1 of 2).

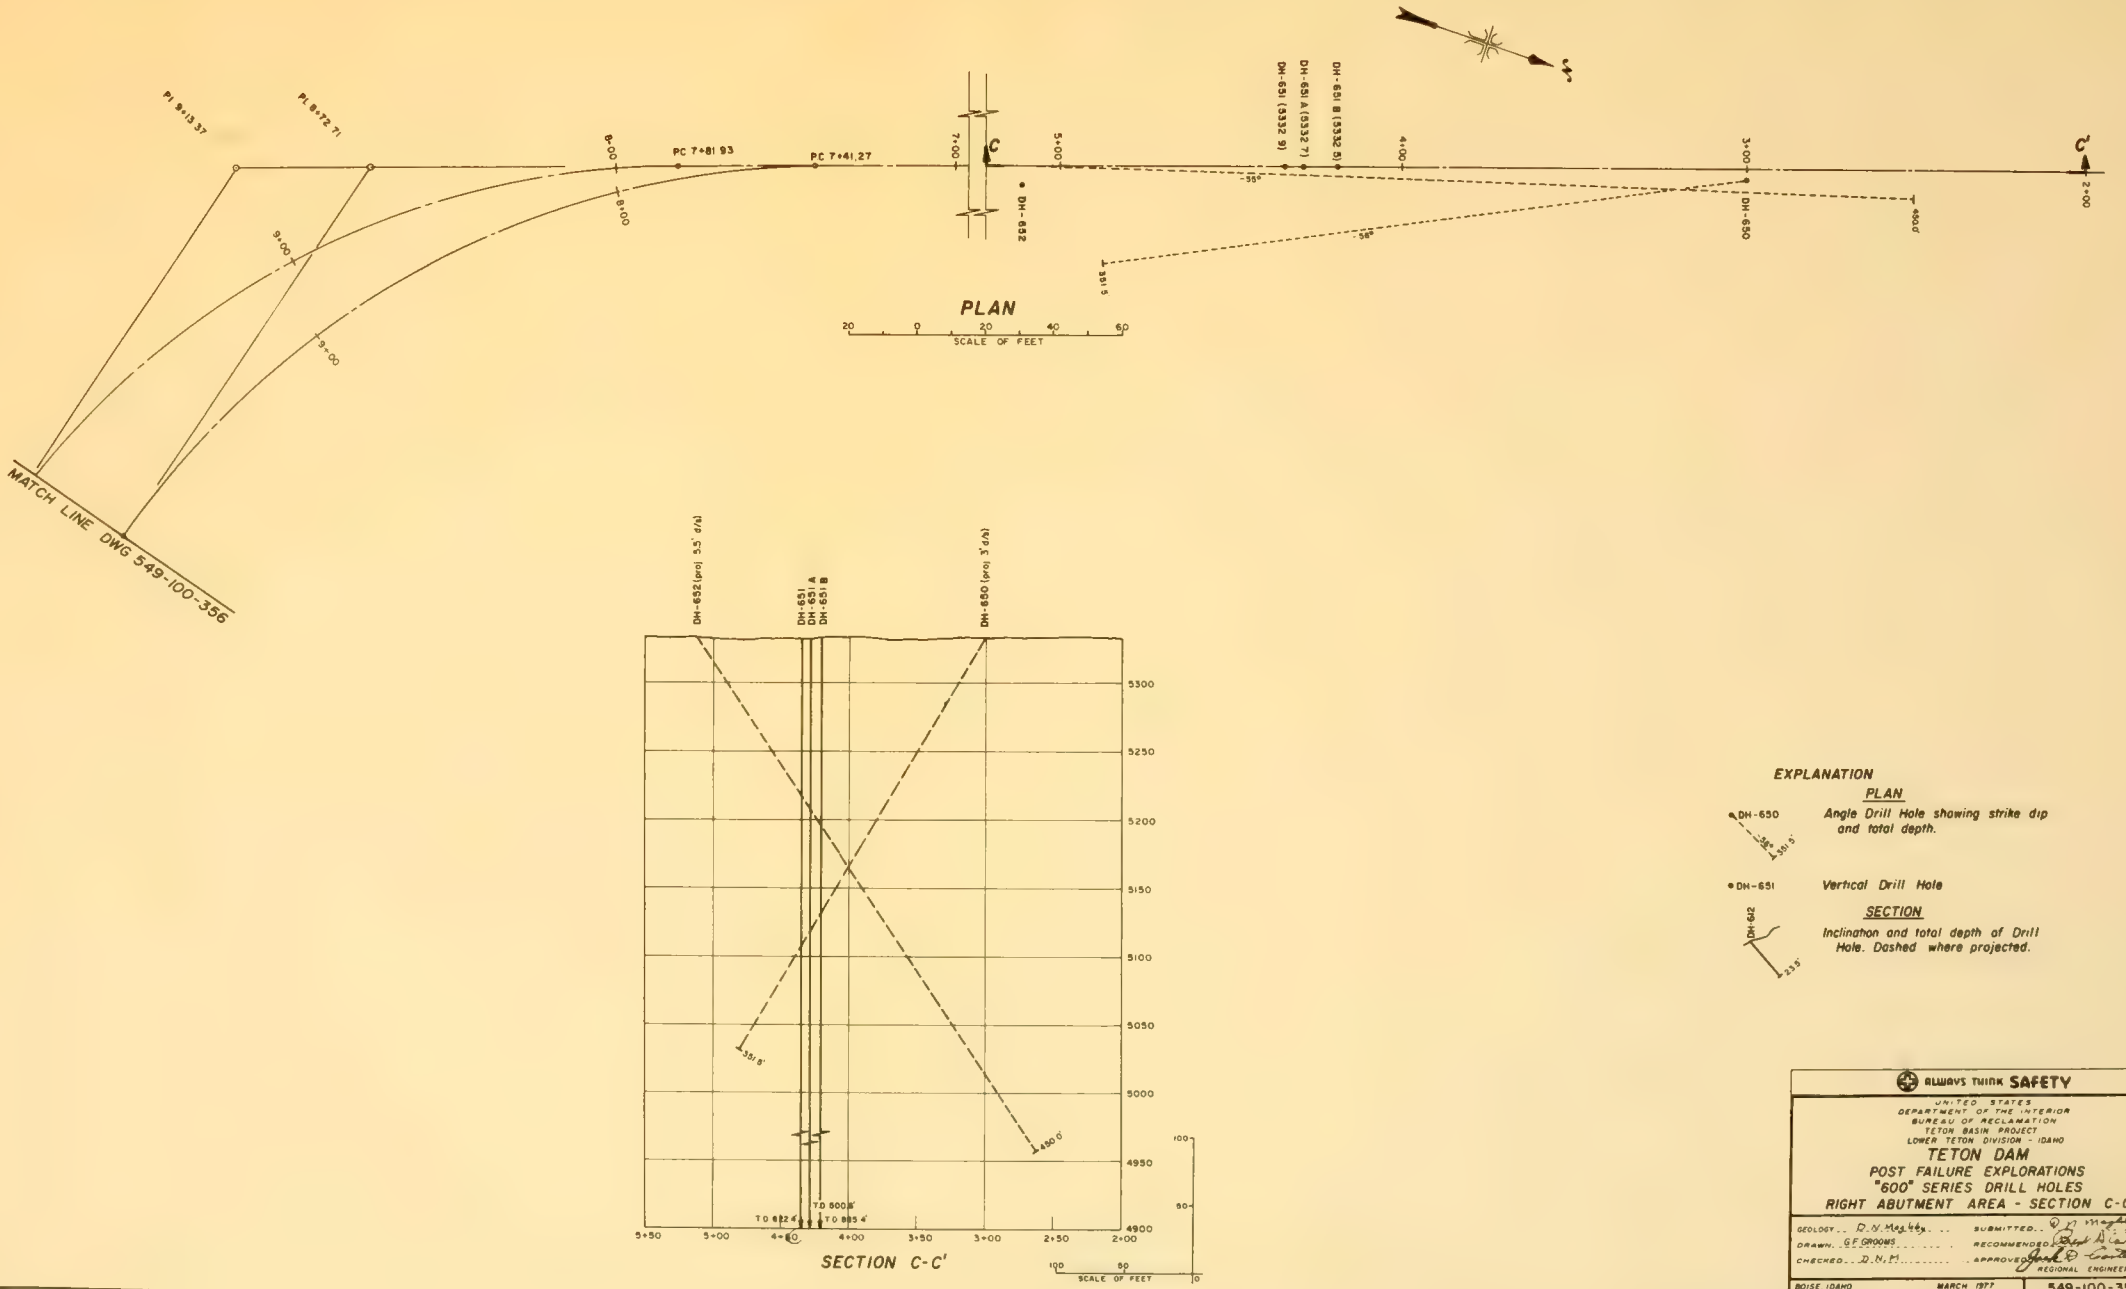
Figure 32.—Locations of postfailure core borings (sheet 2 of 2).

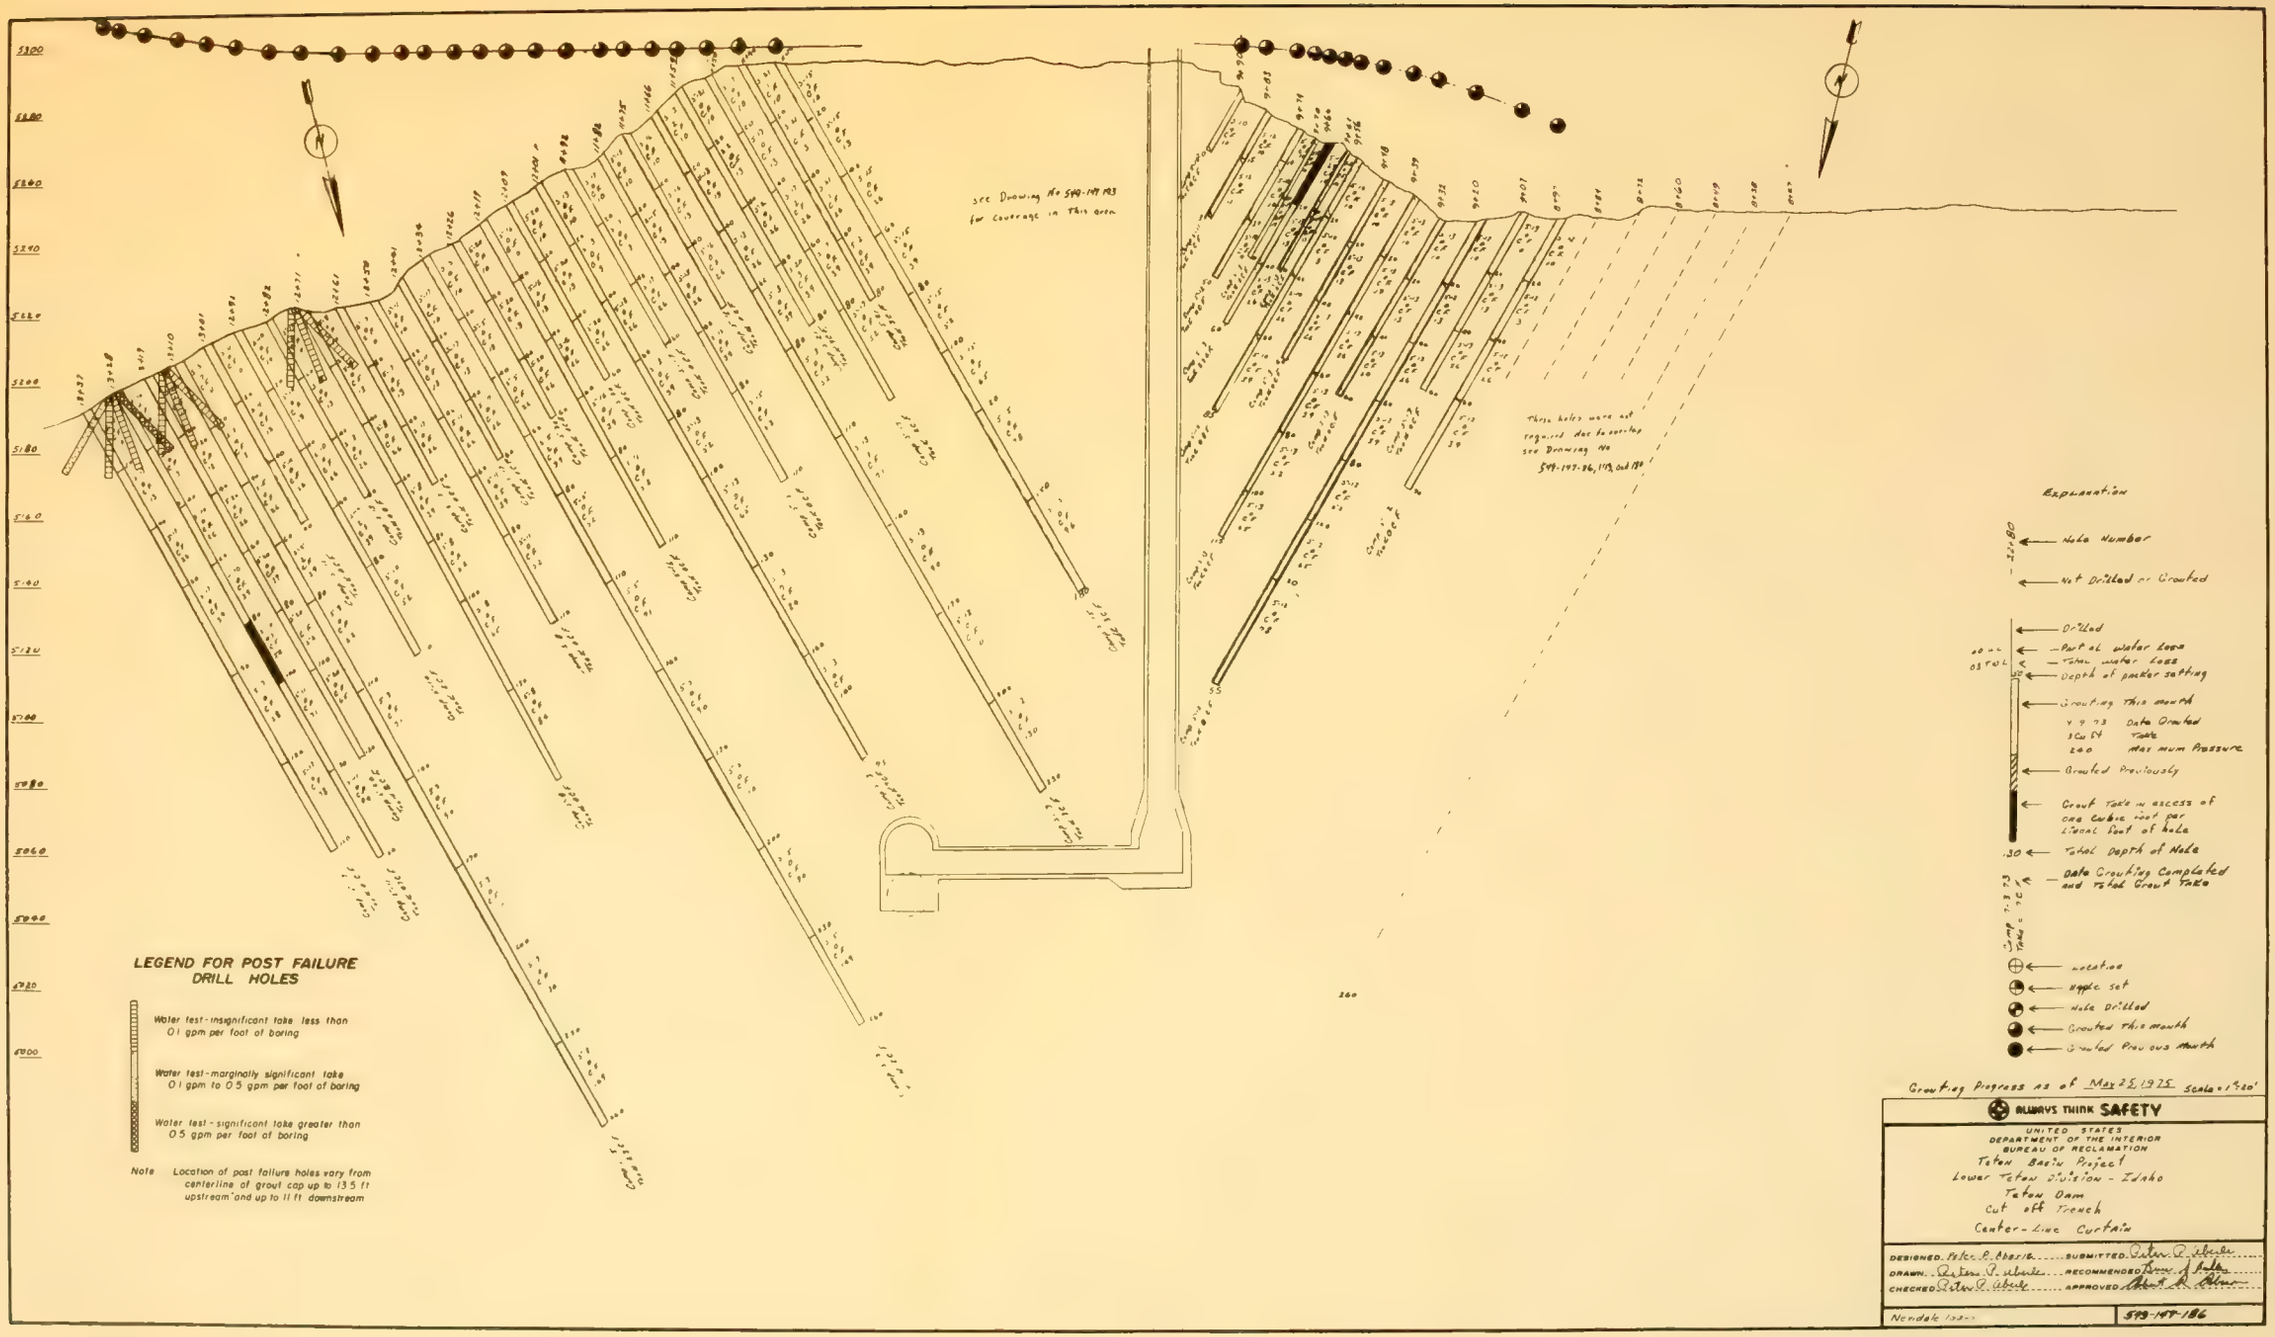
High grout takes were common in the abutment holes. The combined takes of just two of the pilot holes were almost 16,000 sacks of cement and 18,000 cubic feet of sand. Several holes could not be grouted to refusal at depths of less than 70 feet. Grout travel greater than 300 feet was observed. In the canyon floor, the basalt was so fractured that drilling of angled holes was difficult, but the basalt was found to be easily grouted. The alluvial material under the basalt was found to be groutable using three lines of holes, with the two outer lines grouted first.

Figure 33.—Details of the right abutment centerline grout curtain including postfailure core borings (sheet 1 of 3).

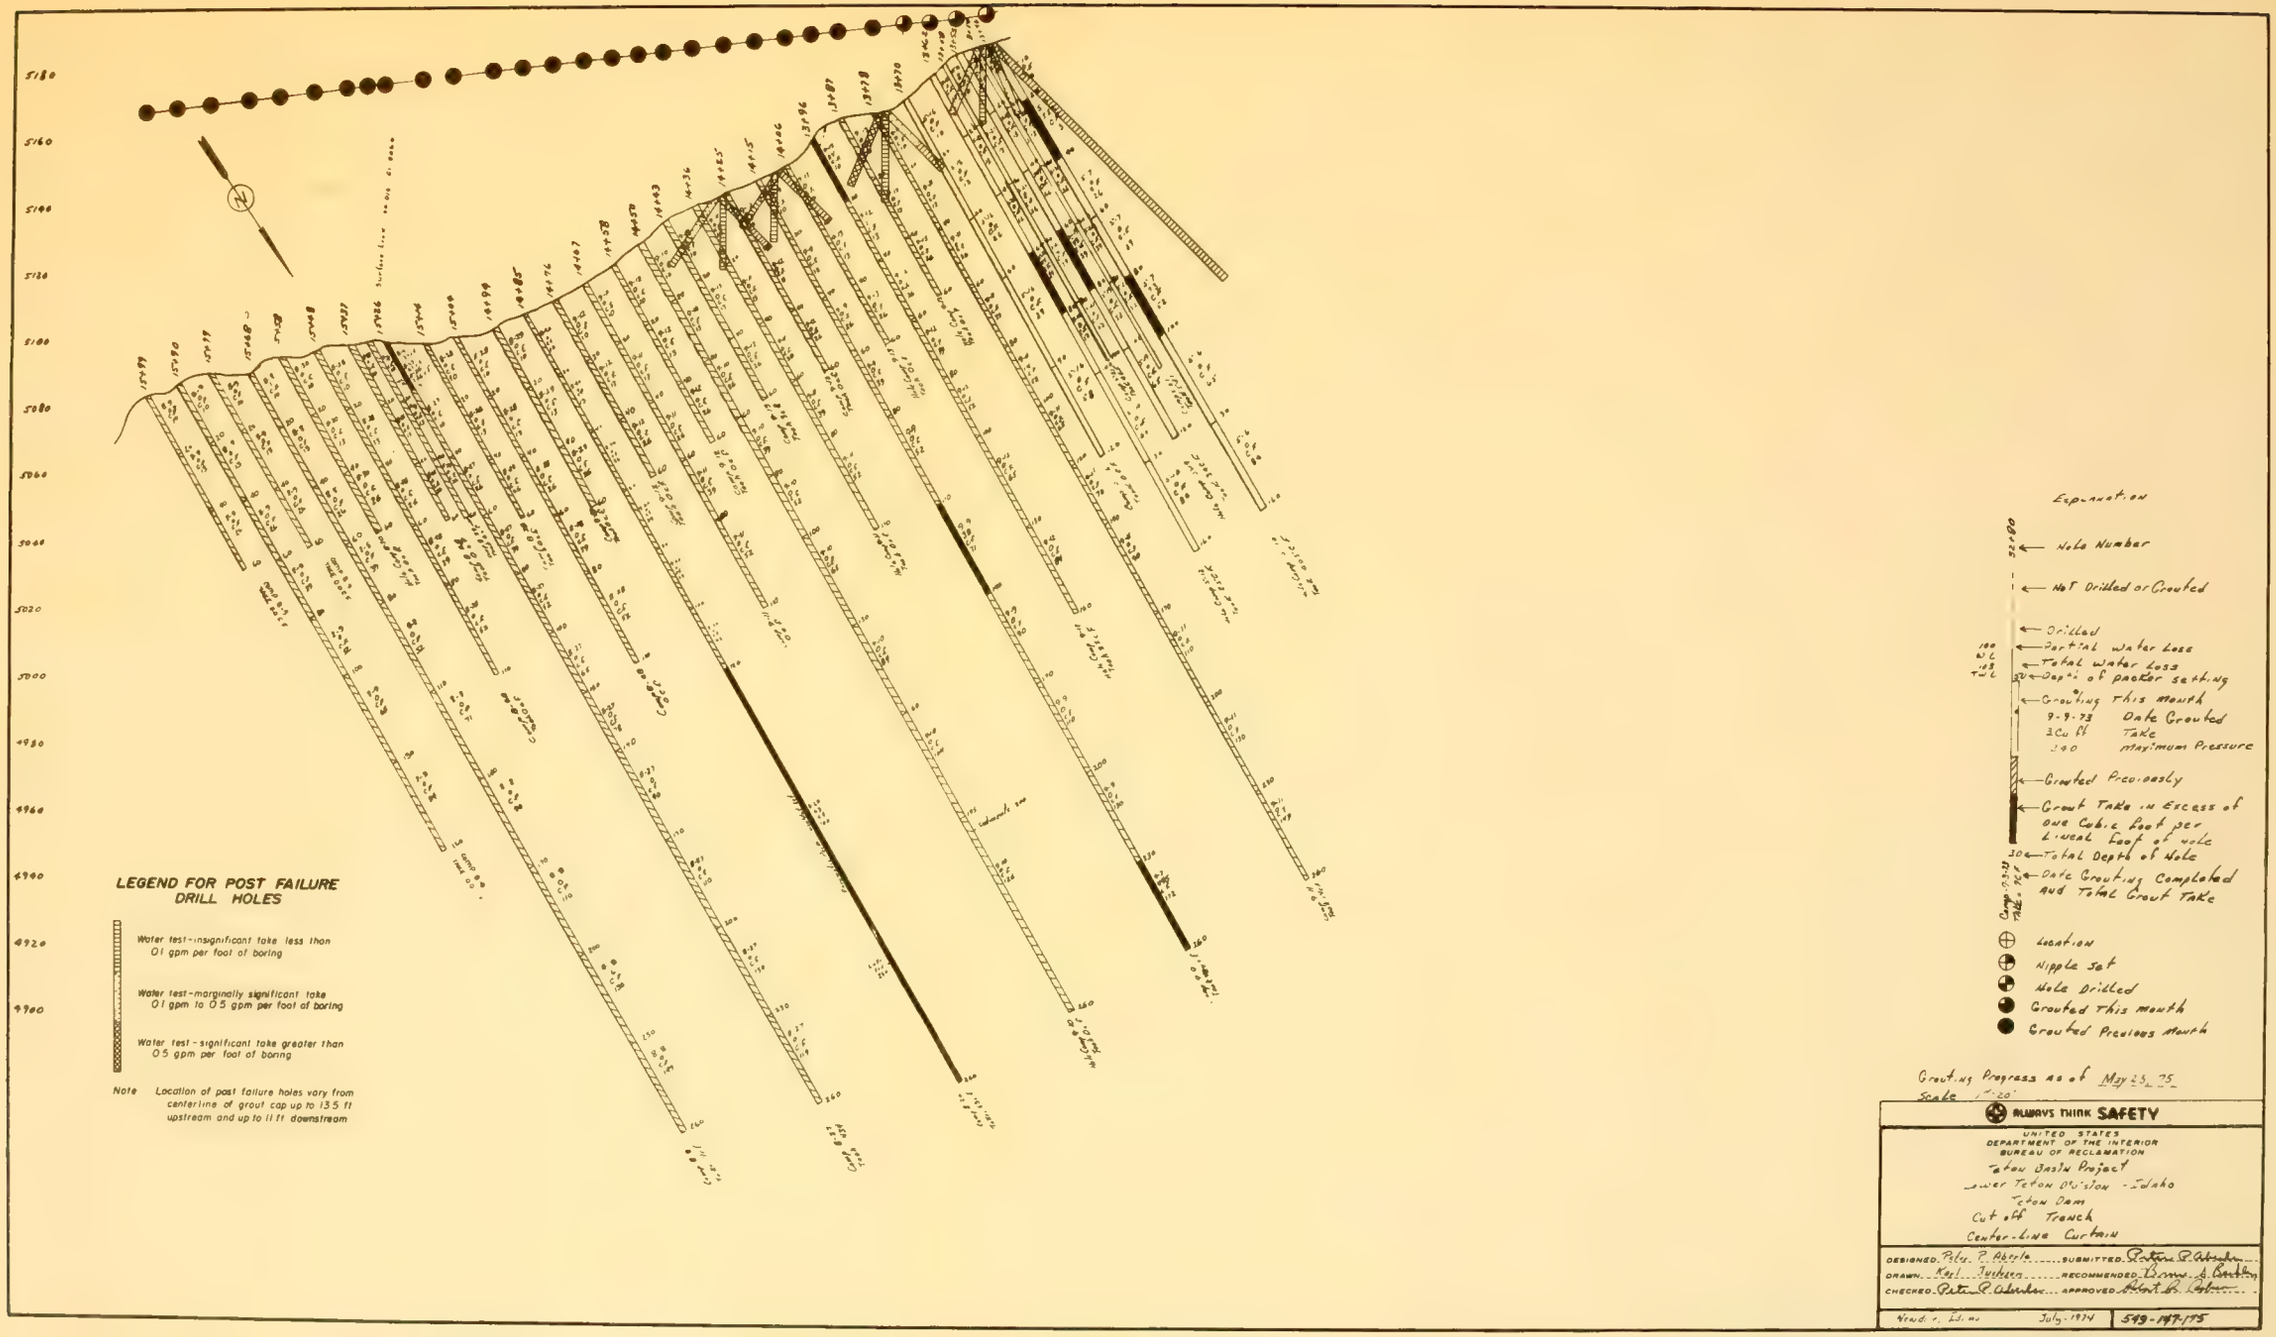
Figure 33.—Details of the right abutment centerline grout curtain including postfailure core borings (sheet 2 of 3).
